測試報告 **Test Report** 號碼(No.): ETR23100373 頁數(Page):1 of 4 日期(Date): 09-Jan-2023 巨昌金屬股份有限公司 (GEU CHONE METAL CO., LTD.) 新北市三重區中興北街176號 (NO. 176, ZHONGXING N. ST., SANCHONG DIST., NEW TAIPEI CITY 241-022, TAIWAN) 以下測試樣品係由申請廠商所提供及確認 (The following sample(s) was/were submitted and identified by the applicant as) : 送樣廠商(Sample Submitted By) 巨昌金屬股份有限公司 (GEU CHONE METAL CO., LTD.) : 樣品名稱(Sample Name) : CARBON STEEL (中碳鋼) 樣品型號(Style/Item No.) : S45C/AISI1045/45# _____ 收件日(Sample Receiving Date) 03-Jan-2023 : 測試期間(Testing Period) : 03-Jan-2023 to 09-Jan-2023 測試需求(Test Requested) 依據客戶指定,參考RoHS指令2011/65/EU Annex II測試鎘、鉛、汞、六價 : 鉻。 (As specified by client, with reference to RoHS Directive 2011/65/EU Annex II to determine Cadmium, Lead, Mercury, Cr(VI) contents in the submitted sample(s).) 測試結果(Test Results) 請參閱下一頁 (Please refer to following pages.) :

測試部位敘述 (Test Part Description)

No.1 : 銀色金屬 (SILVER COLORED METAL)

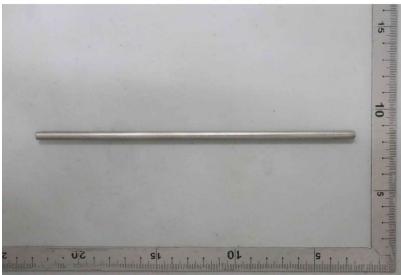
ETR23100373

照片中如有箭頭標示,則表示為實際檢測之樣品/部位. (The tested sample / part is marked by an arrow if it's shown on the photo.)
