Test Report

樣品名稱(Sample Name) : STAINLESS STEEL (不銹鋼)

樣品型號(Style/Item No.) : SUS630/17-4PH

測試需求(Test Requested) : 依據客戶指定・參考RoHS 2011/65/EU Annex Ⅱ及其修訂指令(EU)

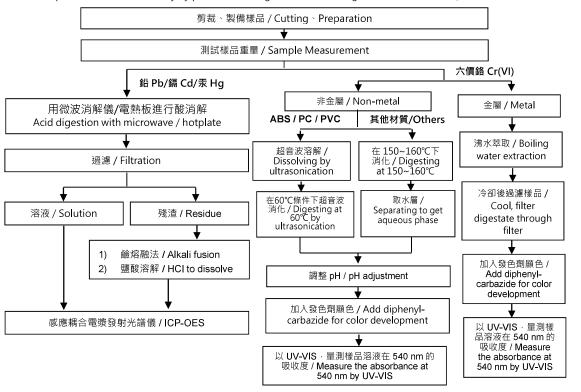
重金屬流程圖 / Analytical flow chart of Heavy Metal

根據以下的流程圖之條件,樣品已完全溶解。(六價鉻測試方法除外)

These samples were dissolved totally by pre-conditioning method according to below flow chart. (Cr^{6+} test method excluded)

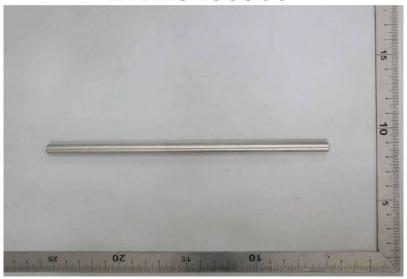
ETR23100366

* 照片中如有箭頭標示,則表示為實際檢測之樣品/部位. * (The tested sample / part is marked by an arrow if it's shown on the photo.)
